Name Of Dam: LAKELAND  
Location: CAMPBELL COUNTY.  
Inventory Number: VA 03111

## PHASE I INSPECTION REPORT NATIONAL DAM SAFTY PROGRAM

NOVEMBER 1980

4. TITLE (and Subtitle) Phase I Inspection Report National Dam Safety Program National Dam Safety Program. Lakeland Dam (Inventory Number VA-03111), James River Basin, Campbell County, Virginia. Phase I Inspection Report.		5. TYPE OF REPORT & PERIOD COVERED Final

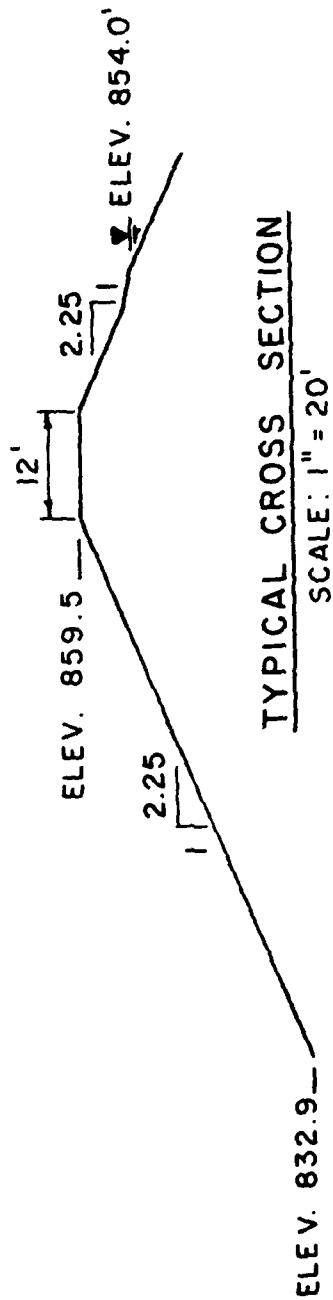
TYPICAL CROSS SECTION

According to the guidelines presented in Design of Small Dams, U. S. Department of the Interior, Bureau of Reclamation for small homogenous dams, with a stable foundation, not subject to a sudden drawdown and composed of a low plastic fines (CL, ML), the recommended slopes are 3.0H:1V upstream and 2.5H:1V downstream. The recommended width is 16 feet. Based on these guidelines, the dam has inadequate slopes and width.

6.3 Evaluation: There is insufficient information to adequately evaluate the stability of the dam. Overtopping is not a problem because the spillways will pass the design flood. It is recommended that the service of a qualified geotechnical engineering firm be engaged to perform a stability check on the dam because of the lack of design data and construction history, and the inadequate slopes and width. This should be completed within 12 months.

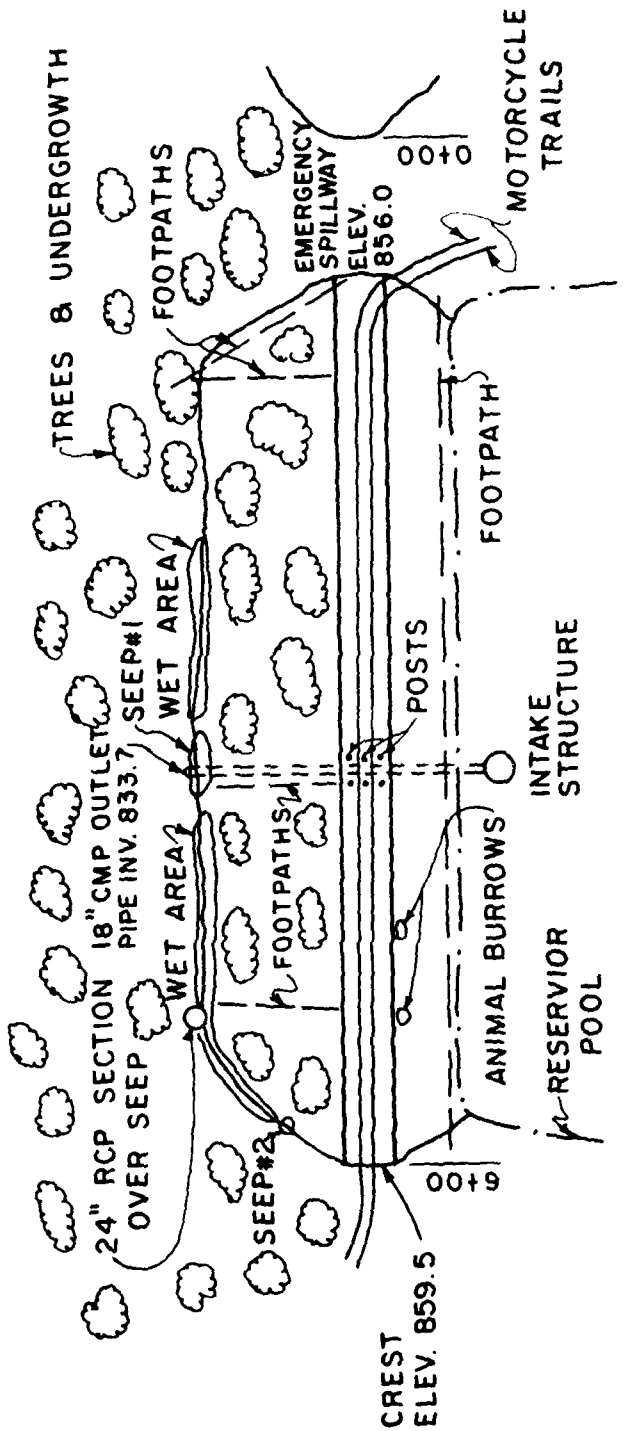
PLAN VIEW OF THE DAM

There are no signs of surface cracks, unusual movement or misalignment. However, there are two animal burrows located on the upstream face of the dam (See Plate II, Appendix I) at station 4+50 and 5+00. The burrow at station 4+50 is about 8 inches in diameter and over 4 feet deep. There is a local sloughing of material around the burrow. The burrow at station 5+00 is much smaller. Two motorcycle trails run up the upstream right abutment, cross the crest and continue up the left abutment. A foot path runs along the waterline on the upstream face and several footpaths run down the downstream face from the crest to the toe.

a. The animal burrows should be filled with compacted material, the surrounding area dressed and seeded.
